All was going well with our new pool and cabana as shown in this photo taken on April 5, 2008. However, our pool contractor just walked out, with about \$240,000 in his pocket and with only promises to continue work on our pool. Here is his web page: <http://www.boomerblockpools.com/designer.htm>.

The rest of the pages are pictures of the pool as they are today, two months later. This is how the back yard looks from the front street and our driveway.

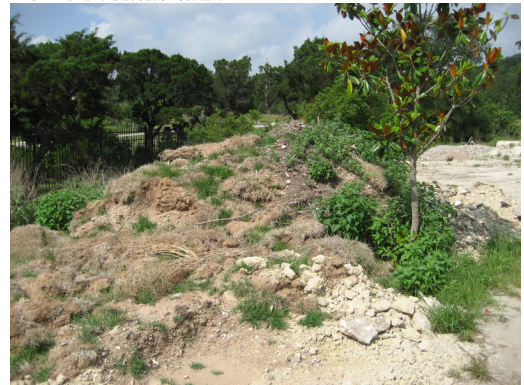
This hill of dirt is about 5 feet tall.

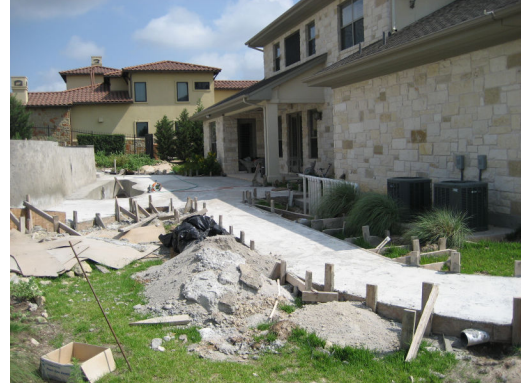
This is what we see behind our house. Note there was no cleanup effort made.

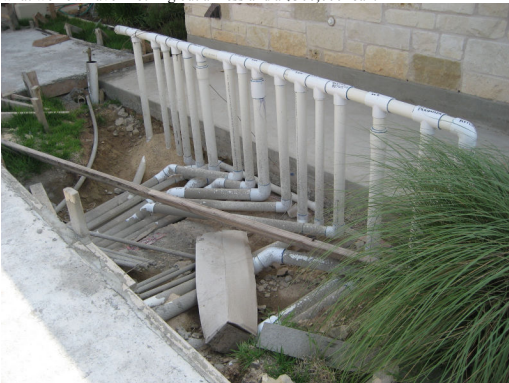
Boomer specifically asked for the money to buy the pool equipment and this is what we now have –nothing but a mess and a \$300,000 loan.

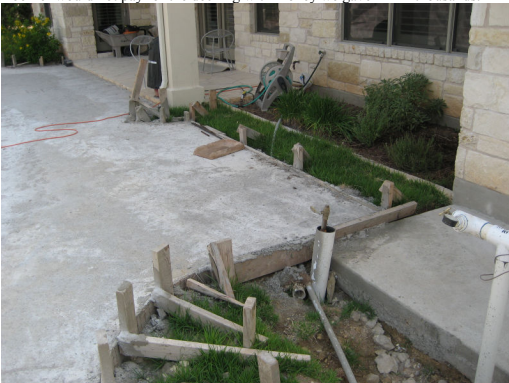
Boomer would not pay for the decking with money we gave him – thousands.

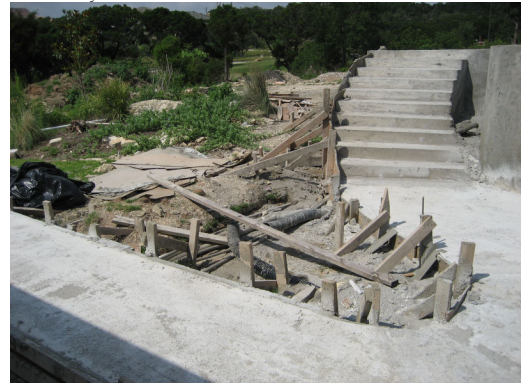
Trash is everywhere.

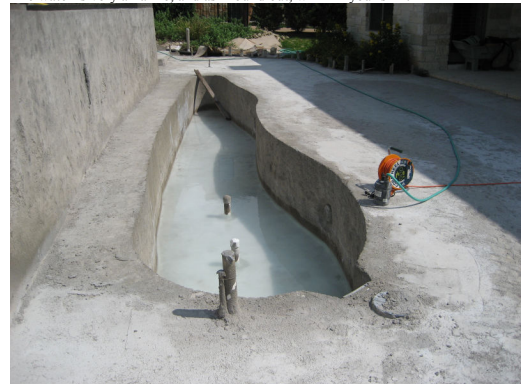
The water is very alkaline, and as I found out, will kill your skin.

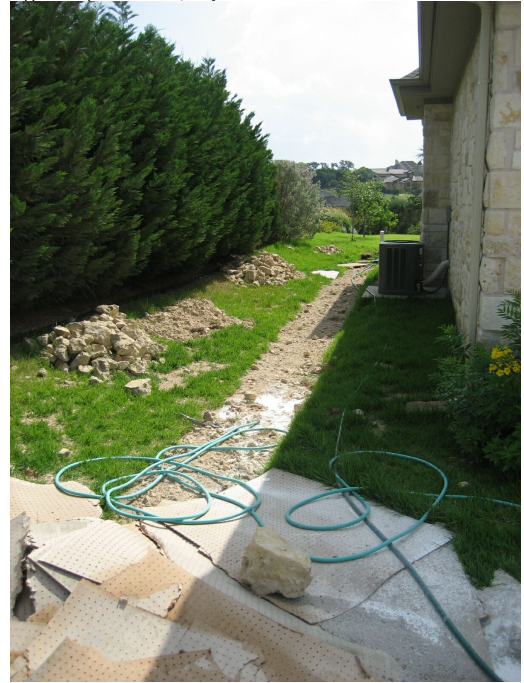
This is looking down the side of our house where the sewer and water lines run. We had to pay an extra \$800 just to get the sewer line covered up. Boomer was supposed to provide all this, but you can see that he didn't finish.

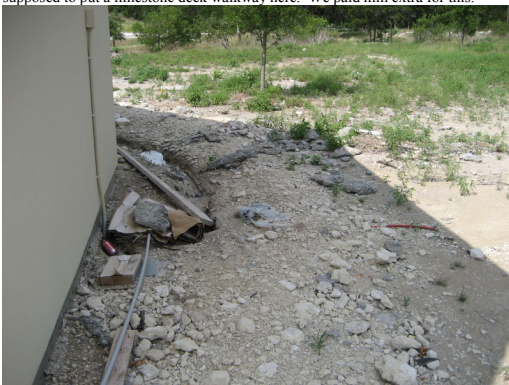
This is just past where the sewer line comes into the cabana. Boomer was supposed to put a limestone deck walkway here. We paid him extra for this.

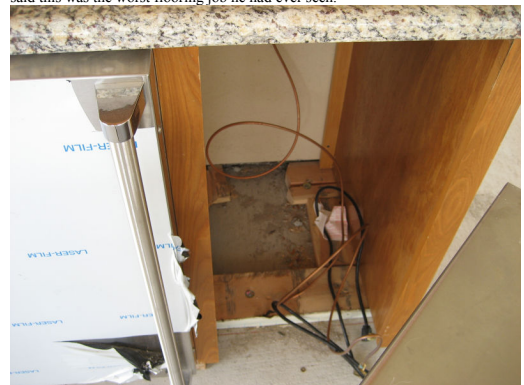
The decking in the cabana was never put in by Boomer. The ice maker installer said this was the worst flooring job he had ever seen.

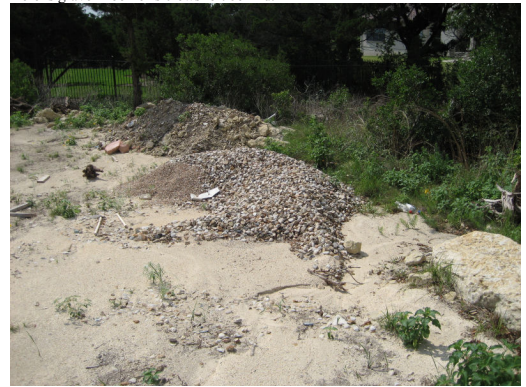
Here is gravel Boomer's crews left behind.

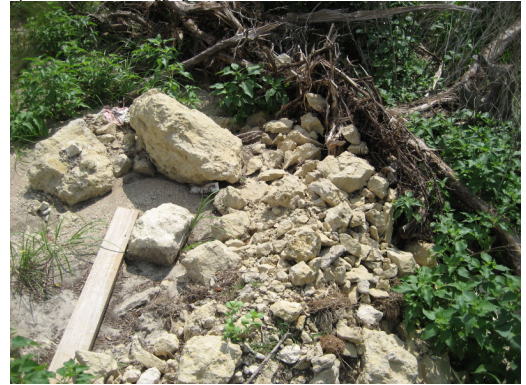
Spoils left over from diggings.

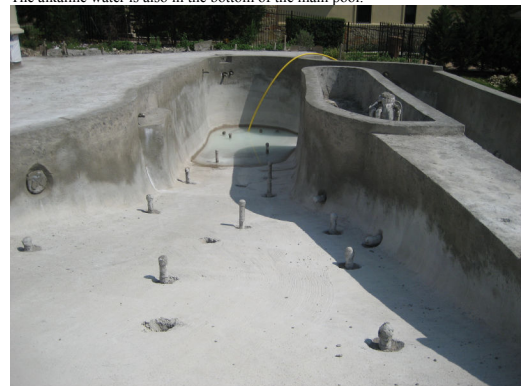
The alkaline water is also in the bottom of the main pool.

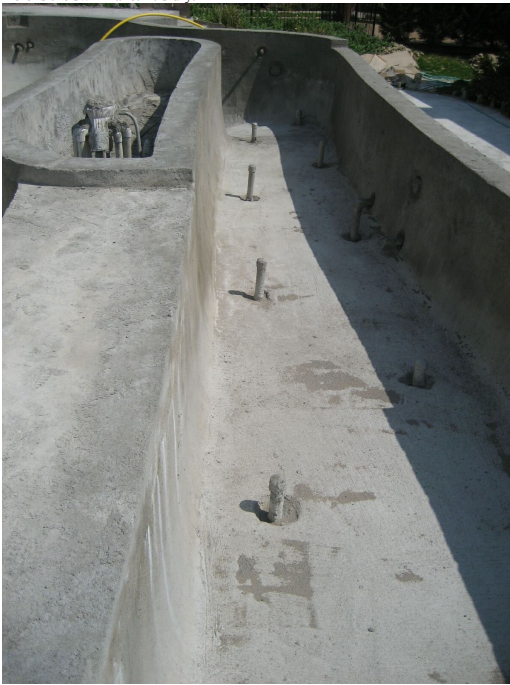
Here is the swim lane. It's dry.

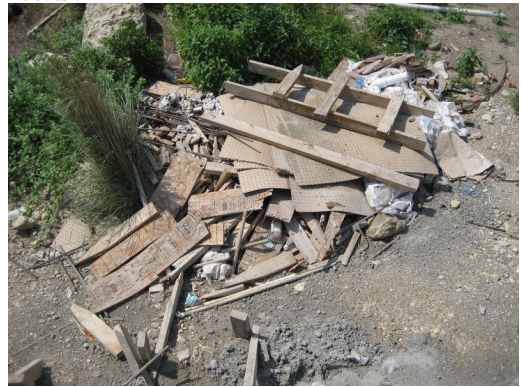
More trash.

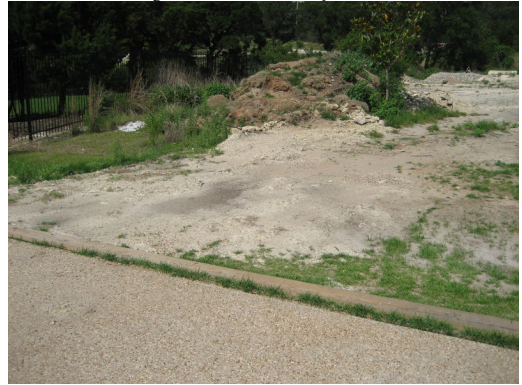
We used to have drainage here. Now its blocked by a mound of dirt.

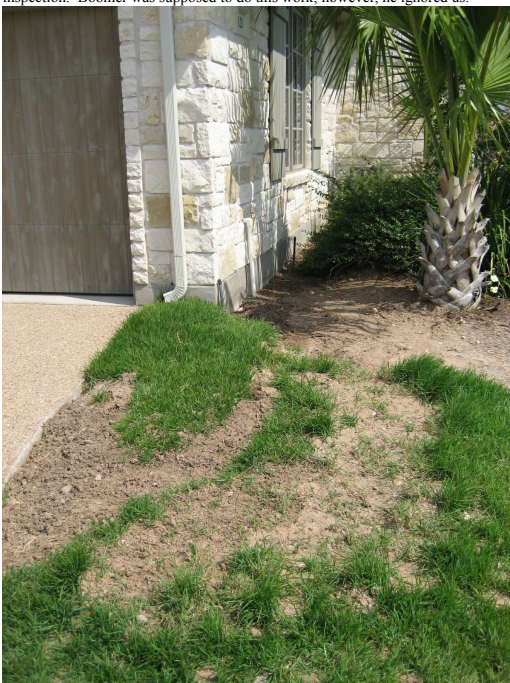
Cheryl and I had to finish the gas line connection at the front of the house ourselves. We finally contacted the inspector and paid him to do a new inspection. Boomer was supposed to do this work; however, he ignored us.
